si 881219-14 e

Ref.: EM 2003 TV

Fault: 50 Hz hum when the EM 2003 TV receives an RF-carrier without modulation.

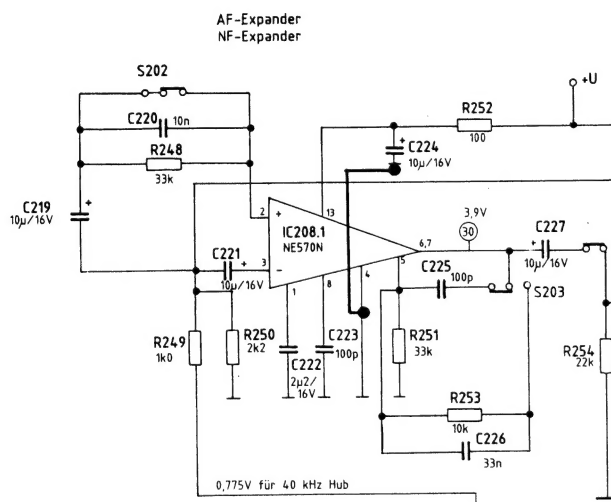
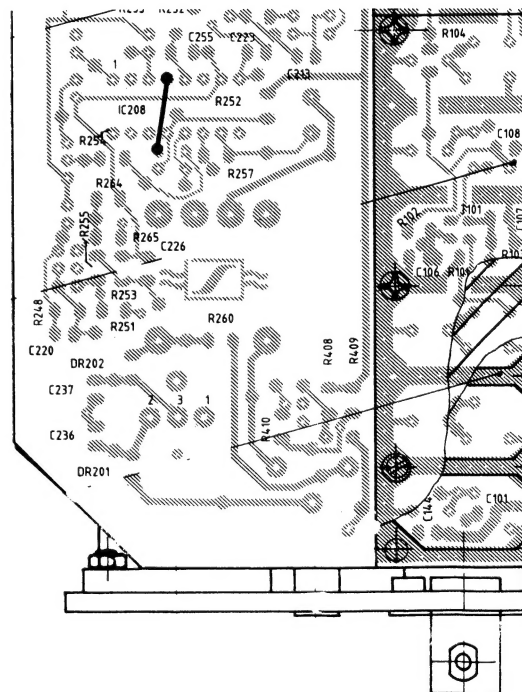
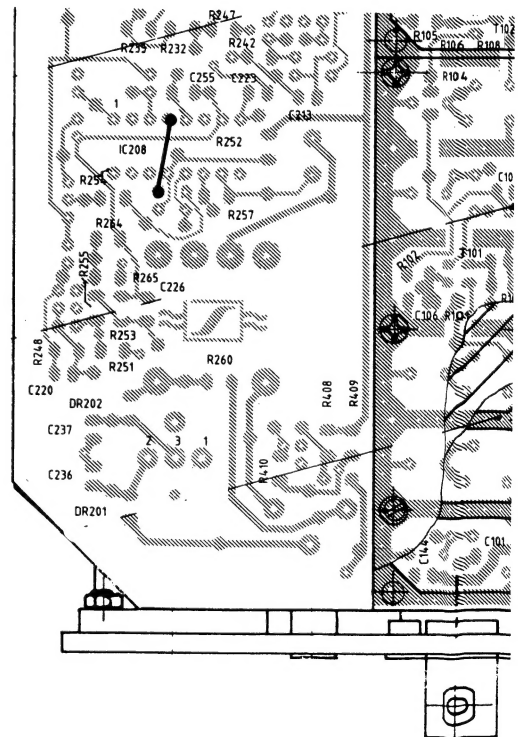
Cause: Insufficient ground connection at HiDyn-IC

Remedy: Connect ground connection of IC 208.1 to ground connection of IC 224. This will reduce the hum by 6 dB.
